Double-jacketed gaskets for heat exchangers sealability behavior in flanges with and without nubbin

ABSTRACT

Due to their large size, double-jacketed gaskets used in shell and tube heat exchangers¹ are manufactured by radial bending of pre-fabricated jacketed strip and joined by butt-welding of the metal jacket ends².

This paper reports the results of a study to show the sealability behavior of the butt-welded DJ gaskets and their joint resistance, when installed in flanges with and without nubbin³ varying the seating stress.

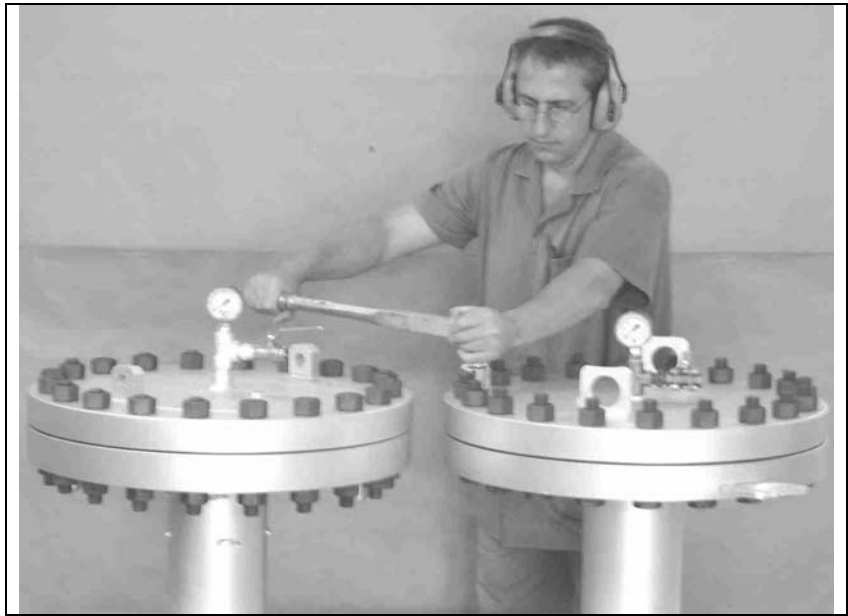
Figure 8 – Sealability test stands

Two test stands were used, one with a nubbin and the other without a nubbin. Both were made with a pair of flanges with twenty 1 inch diameter bolts, as shown in Figures 8 and 13.

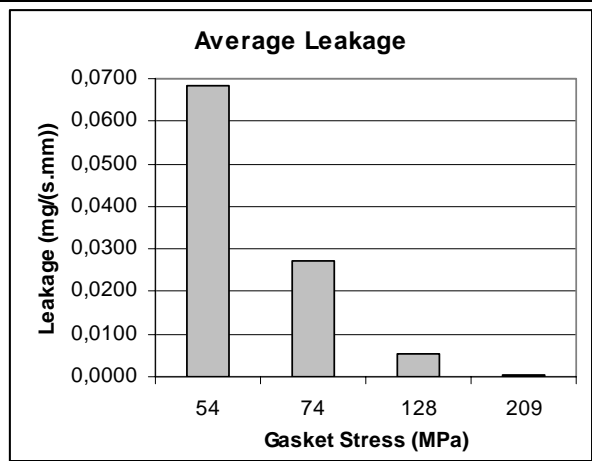
Figure 20 - Flange with nubbin, gasket centered with groove. Overlap opposite nubbin.

The sealability test results are shown in Tables 5 and 6 and Figures 18 through 22.

Comparing the values of Figures 18 through 22 the flanges with nubbin have a higher leakage than flanges without nubbin for the lower values of seating stress. At higher seating stresses this difference is less except for gaskets installed per Figure 15 as shown in Figure 22. These results show that the nubbin did not increase the gasket sealability and that the erroneous installation with the overlap towards the nubbin showed the worse results
